Greenspace 6- Herrington Burn

5.1 Habitat Restoration aims at Herrington Burn at Shiny Row

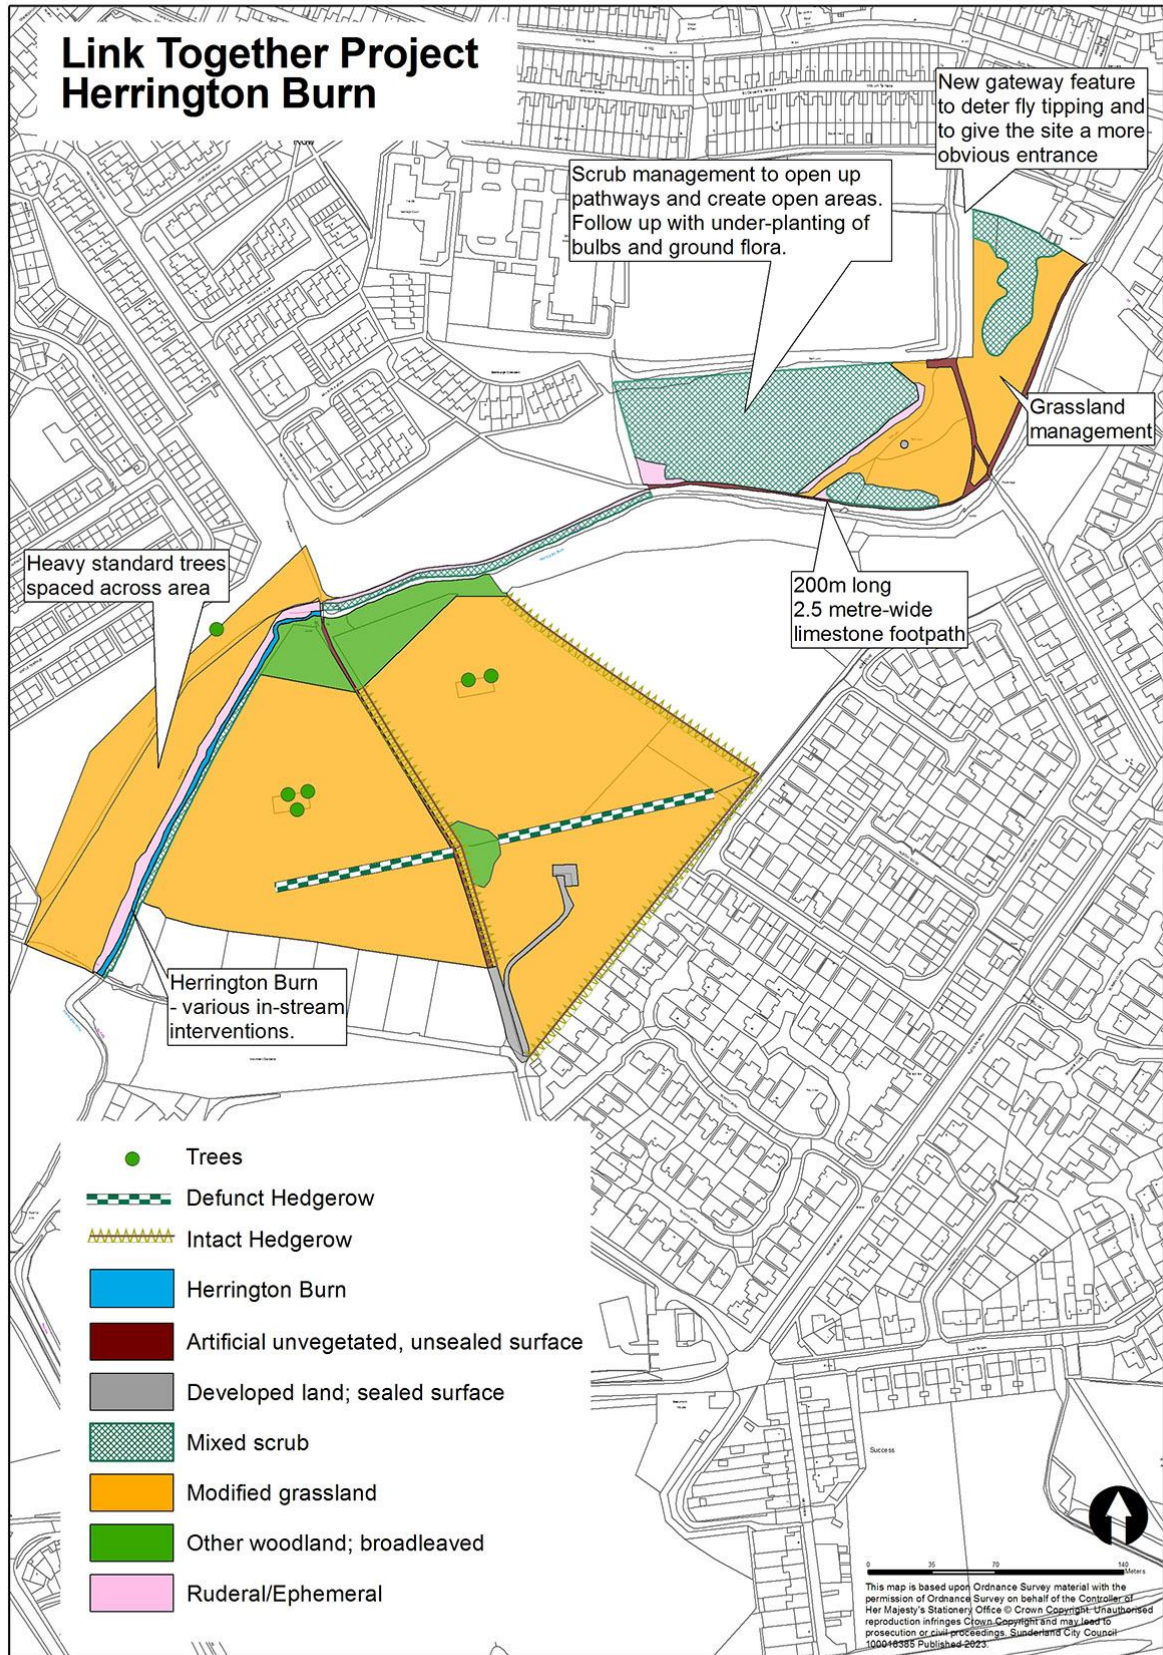
5.0 Proposed Works (See also map further below)

- To improve Herrington Burn visually and habitat value by a series of in-stream interventions including green bank protection, re-meanders to stream, large woody debris, channel aggradation, fish easement and livestock fencing
- To improve diversity of scrub and create open areas
- To improve grassland quality through management programme
- To improve water quality by reducing run off and litter entering the water.
- To remove Himalayan Balsam, Japanese Knotweed and Montbretia along Herrington Burn from Herrington Country Park.

- To provide greater identity and quality to routes and connections with surrounding greenspaces.
- To improve entrance from South View to elevate the character of the area to be more welcoming and to deter fly tipping.
- To resurface a 200m section of footpath.
