Greenspace 8- Hetton Bogs

1.0 Introduction

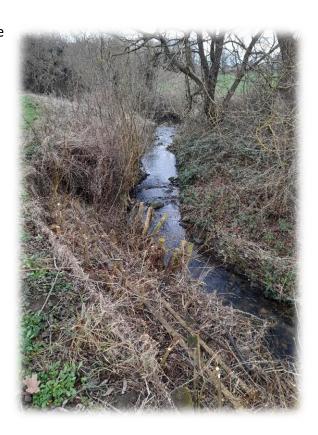
3.3 Ongoing management of the ponds by removing excess Typha and coppicing some of the willow to increase areas of open water and increase light levels would be beneficial. This would also provide additional refuge for water voles. Maintaining some areas of tree cover alongside the path would provide protection from disturbance from walkers and, particularly, dogs.

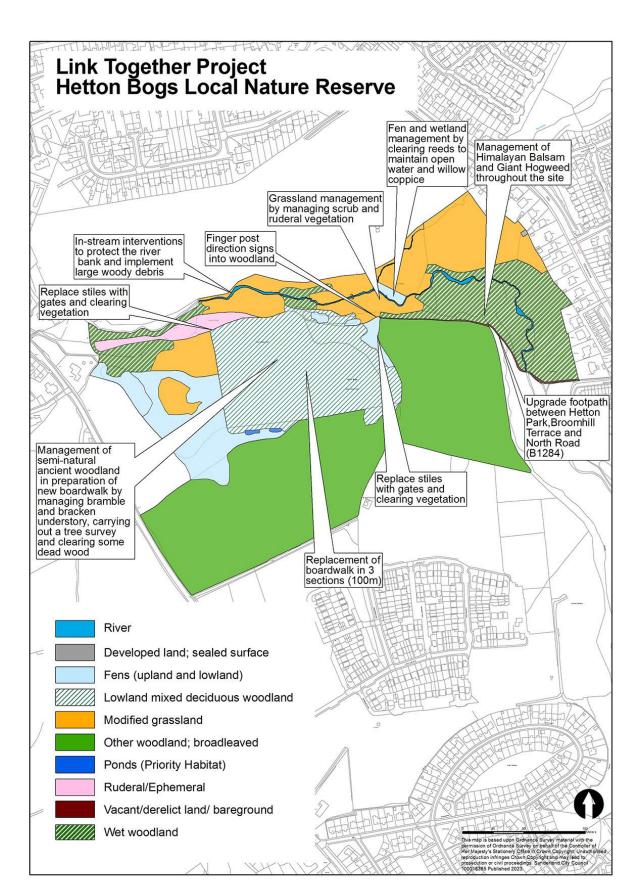
Locations of proposed works are shown in the map below.

5.1 Habitat Management at Hetton Bogs:

- To maintain banksides at Hetton Burn and maintain good habitat for water vole;
- To manage and reduce the presence of Himalayan Balsam;
- To enhance areas of grassland;
- To enhance areas of fenland.

5.2 Access and Interpretation:

- To substantially upgrade the footpath through Hetton Bogs in order to capture and support usage increases arising from adjacent housing development;
- To maintain through signing in accordance with the standards expected on definitive PROW ('easy to find and follow and use');
- To improve access into and through semi-natural ancient woodland.
